Respect the Property you Inspect

Graham Stone of Stonehouse Property Care gives his personal views about inspection and repair of historic and listed properties

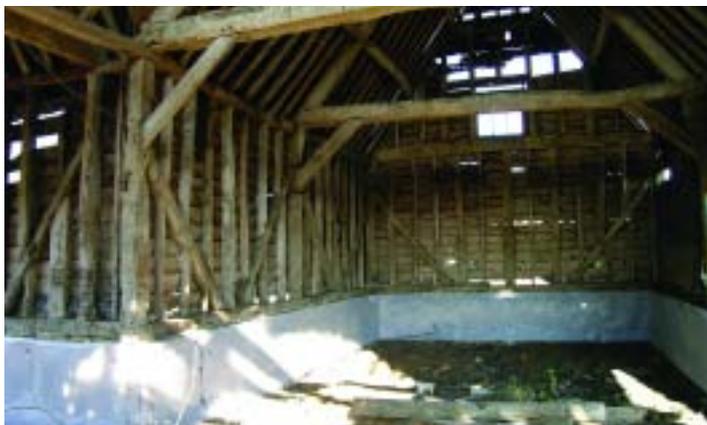
Example 1 – Grade 2 Barn Conversion

When asked to damp-proof an elm timber-framed barn on a stone plinth we suggested the plinth was lined with Newton 500 cavity drain membrane prior to a new concrete floor being laid. This isolates the new concrete from the stone wall, allows the stone wall to dry naturally without re-directing rising dampness to the underside of the soleplate.

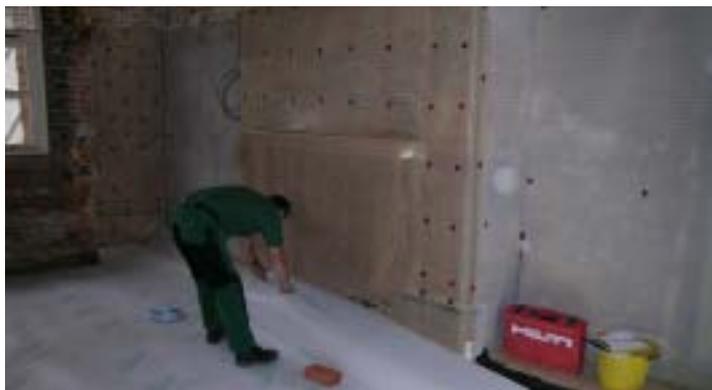
Example 2 – A Grade I listed property in Winchester where the existing basement area is to be used as a kitchen.

Our scheme was approved with a Newton 500 cavity membrane laid against an external, below ground wall, running to a Basedrain drainage channel in the floor with natural drainage to the rear lightwell. Fixings were drilled through the mortar joints to fix the membrane and all could be pulled off to reveal undisturbed wall finishes.

The wall was then dry-lined prior to a kitchen being fitted. The dry void between membrane and plaster allowed for all the services to run neatly yet still remaining accessible.

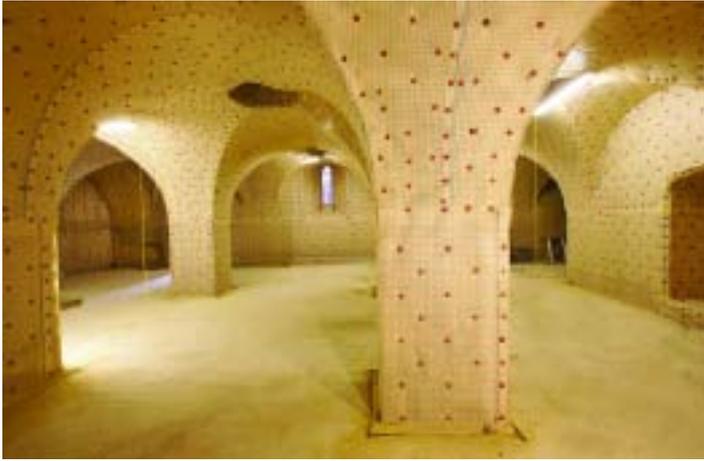
Example 3 – The Royal Courts of Justice

This is a Grade I listed building in Central London where space is a premium. It is, however, located in a confined site but extensive basements exist below the building. Proposals to waterproof these areas using cementitious 'tanking' systems were rejected. Designing a system utilising Newton 500 cavity drain membranes, allowed these underground spaces to be transformed. None of the historic fabric was disturbed and by removing the fixings located into the mortar joints the whole system can be reversed. This solution was acceptable to English Heritage, the conservation architect, the owner and complied fully with BS8102.

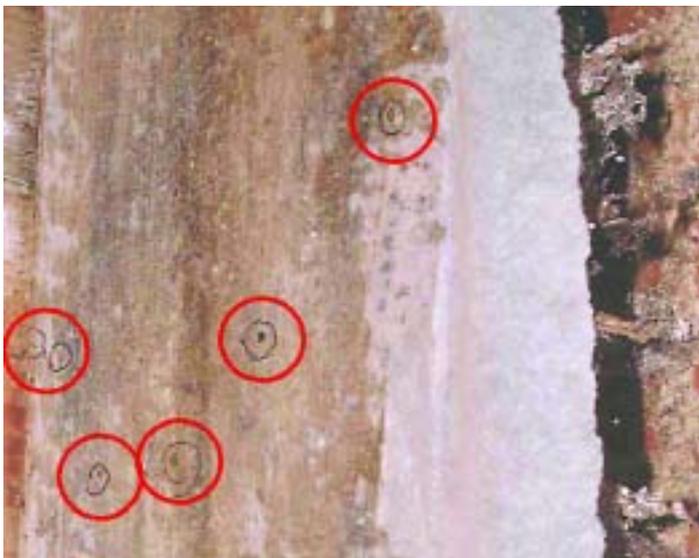
Example 4 – Timber-framed office building in Henley

In early 2001, we were called to inspect second floor joists in a timber framed building in Henley. Rewiring had exposed timbers with holes.

These emergence holes were clearly Death Watch Beetle, all were bright, clean with frass visible but absolutely dry. It appeared active but was unlikely to be. It would also have been a major upheaval to treat since all the offices would have had to be cleared. We opted to monitor the beetle. We glued paper to all the suspect timbers which were annotated on a plan. Within our fee we revisit annually to check for activity. Any new holes which emerge through the paper will indicate the outbreak is current, so far no signs of activity, indicating that the original fresh looking frass must have been caused by loosening due to vibration.

We used our knowledge to establish whether treatment was required, the client was not disturbed needlessly and no chemicals were used. We saved the client money and prevented unnecessary treatment.

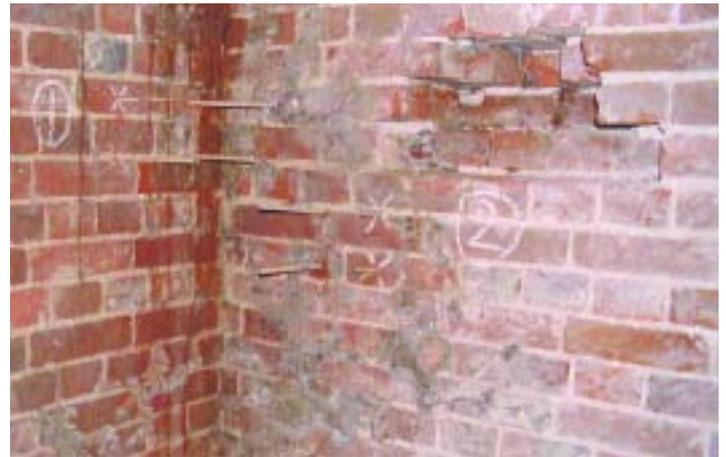
Example 5 – A Grade I listed Stable block in Basingstoke

Here defective guttering had caused an outbreak of Dry Rot. The gutter was renewed prior to the repair of defective timbers. We installed a series of dowels into the wall fabric to monitor the drying of the structure and any decay to the timbers.

The Dry Rot died out naturally, no chemicals were used to control the outbreak.
